# EQUIVALENT INITIAL STRUCTURAL SAFETY ASSESSMENT

Factory Name: **Sawftex Ltd**  
Address: **Bhagnahati, Sreepur, Gazipur Sreepur, Gazipur Dhaka  
Bangladesh**  
Assessor: **Walter P. Moore**  
Date: **07 Mar 2014**

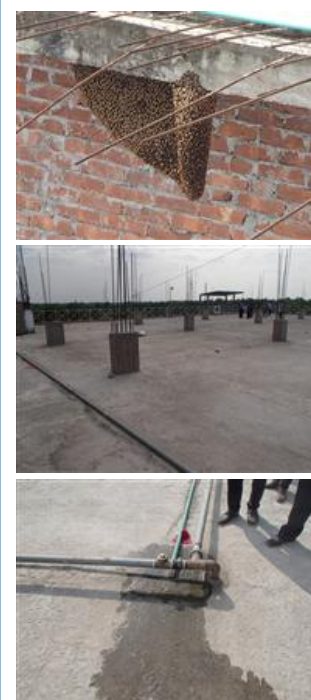
Question:	Have all areas of needed maintenance, including areas with efflorescence, dampness, standing water on rooftops, and corrosion been addressed.
Priority Level:	Medium
Non-Compliance Level:	1
Description:	Exposed reinforcing bars at the NW expansion and roof should be removed and protected from future corrosion. Visible water was noted to be present on the roof that is leaking from rooftop plumbing.
Source of Findings:	Visual Assessment: Observed at the time of our assessment.
Suggested Plan of Action:	Under guidance from a qualified structural engineer, address all areas of needed maintenance by correcting the identified issues.
Suggested Deadline Date:	31 Jan 2015
Standard:	Alliance Standard Part 8 Section 8.26 Durability and Maintenance
